The Drowning Machine
Written by Kim A. Elverum and Tim Smalley
Photos by Tim Smalley
Layout & Design by Sharon Ketelsen

Boat and Water Safety
Minnesota Department of
Natural Resources
500 Lafayette Road
St. Paul, MN 55155-4046

The Drowning Machine

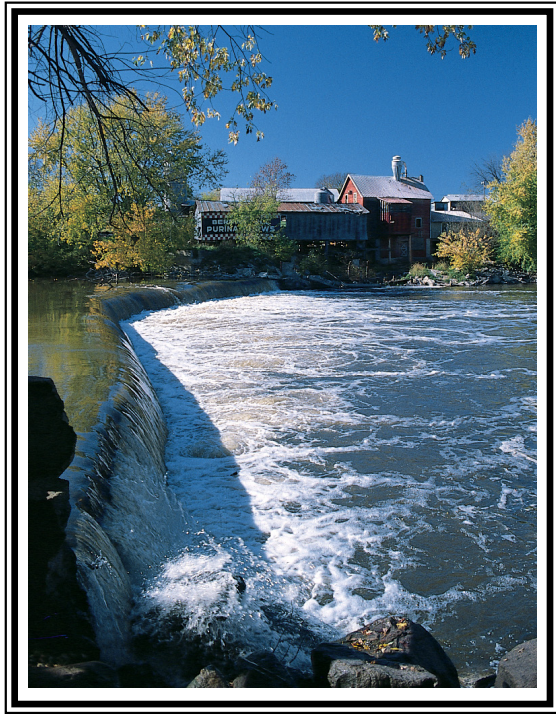
The Berning Mill Dam on the Crow River near St. Michael, Minnesota was typical of a lowhead dam. Water flowing over the top creates a recirculating current drawing objects back toward the face of the structure. Even boats with powerful engines have been trapped and capsized by lowhead dams such as this one. The dam has now been removed as part of a state dam safety program.

In the spring and during other periods of high runoff, however, the dams become very dangerous. Torrents of water pouring over the dam create a churning backwash or current. This “hydraulic,” as it is often called, is really a recirculating current. The roiling water takes any object — including a person — to the bottom of the stream, releases it to the surface, sucks it back to the face of the dam, and pushes it back to the bottom. This cycle can continue indefinitely.

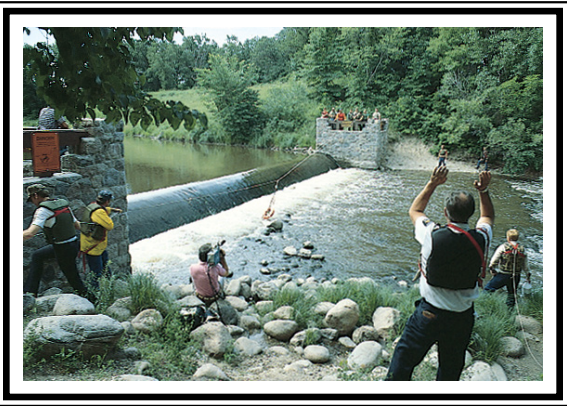
The Minnesota DNR teaches rescue techniques at a Fast-Water Rescue School. In a drill, a rescue team pulls a float through the boil. A victim caught in the boil could hang onto the float and be pulled free.

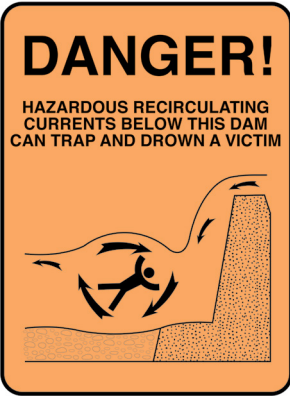
This sign, installed at many dam sites around the state, warns people of the potential danger of a lowhead dam.
